SAFE SAVARI

NEWSLETTER ON ROAD SAFETY

Volume VI, Issue 2

Analysis of Road Accident Causative Factors

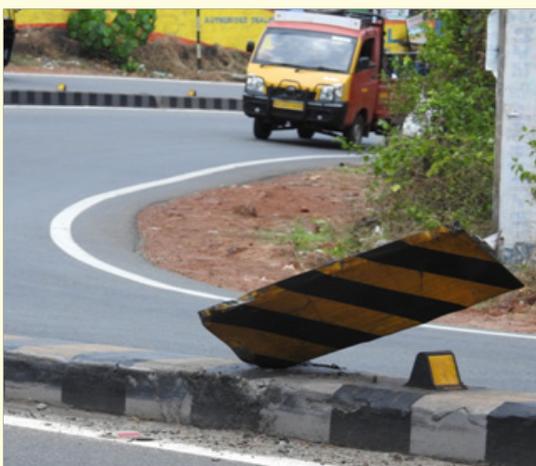
Entry to the curve towards Kottakkal, damaged chevron can be seen

Absence of street lighting as well as median lighting, worn out reflector studs, sign boards with low visibility, absence of hazard marking in the vicinity of the curve, damaged median chevron at the entry into the curve, inadequate surface drainage, diminished rumble strip marking etc. were the major contributing factors of accidents on this road stretch. Several remedial measures were suggested by NATPAC. Bus stop after the curve towards Kozhikode direction was suggested to be shifted. Classified speed limits has to be mentioned at the curve. Awareness programmes aimed at discouraging rash driving has to be carried out by the concerned agencies.

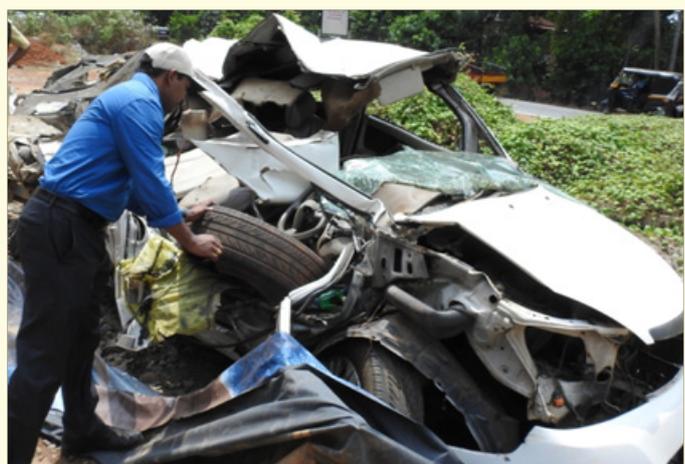
Mangled remains of the car involved in accident

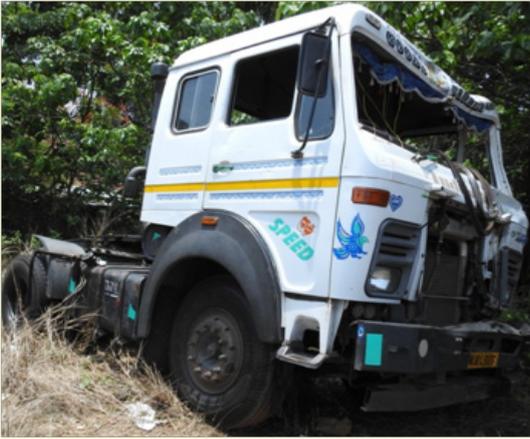
Prime mover of the trailer

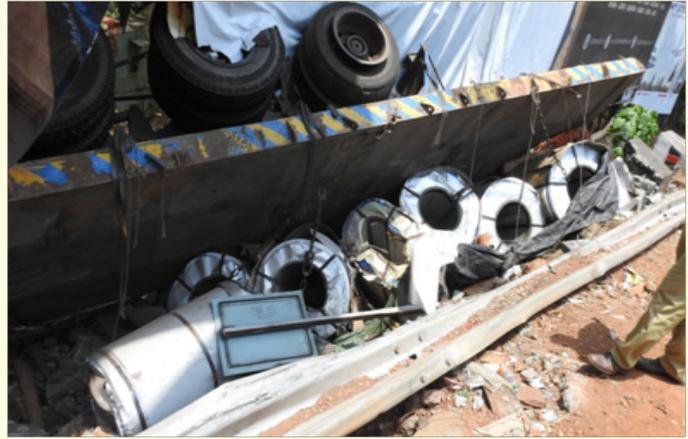
line and hit the right rear end of the victim vehicle, forcing it to slide sidewise. The truck driver immediately oversteered but the excessive speed and wrong drive line caused the trailer to drift off and broke the coupling with the prime mover, turning itself over the victim vehicle and subsequently into the nearby domestic land approximately 12 feet deep, crashing the W-beam barrier and Random Rubble masonry retaining wall.

Capsized trailer

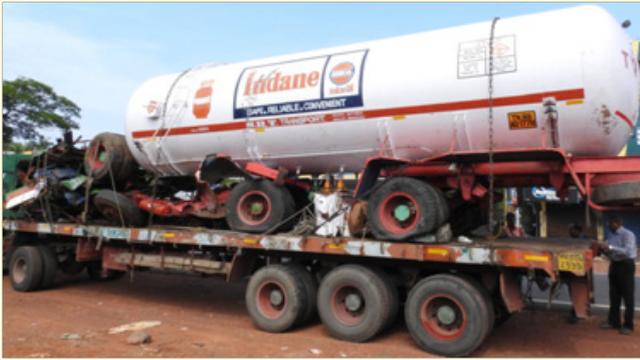
Officials from NATPAC visited the accident spot on 11th May 2016. The driver of the tanker lost control at the rumble strips and applied clutch to downshift which accelerated the vehicle at the gradient. Due to over steering, the trailer that carried the bullet drifted and capsized, forcing the coupling with the prime mover to rip off, thus throwing the bullet into a gorge, breaking the rubble masonry barrier, to a depth of approximately 30 feet. Since this is an accident prone area, caution signs have been erected for speed limit, drive gear selection and depth of danger.

Capsized tanker

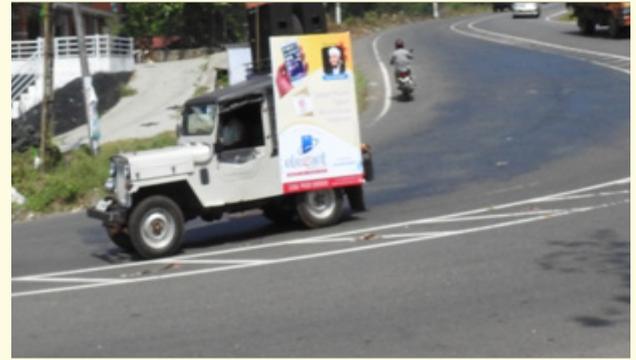
Illegal driving and overtaking at the spot and diminished road markings at the curve

Invisible outer shoulder marking, absence of street lighting, less speed calming measures, worn out reflector studs etc. were the major contributing factors of accidents on this road stretch. Awareness programmes aimed at discouraging rash driving must be carried out by the concerned agencies through training programmes, audio-visual media, social media etc.

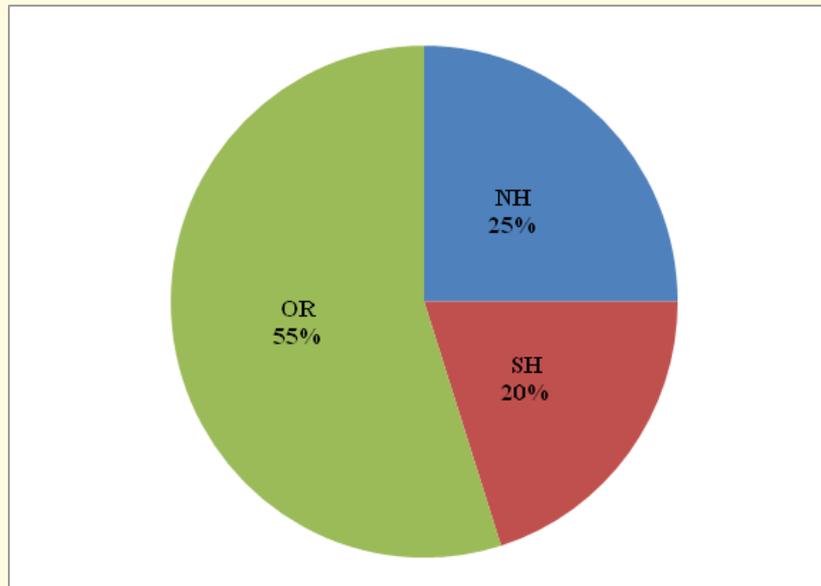
Road type-wise share of road accidents – 2016 (April-June)

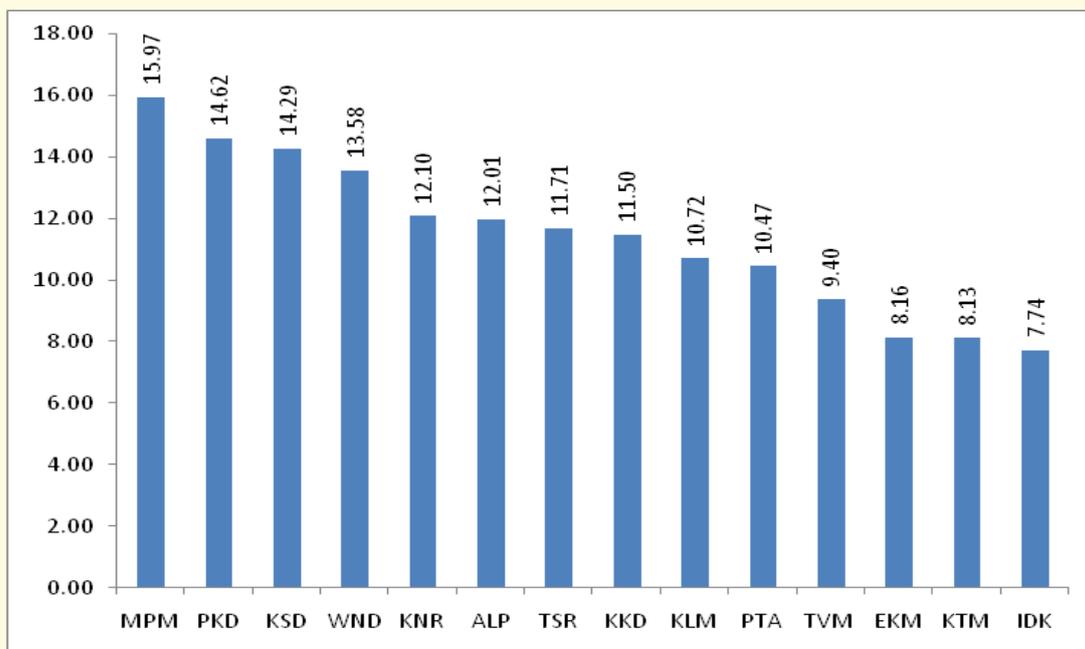
District - wise severity index* (April-June 2016)

Severity index*- # fatalities per 100 road accidents
